Michael Dandurand, P.E.
637 East Willow Street
Gardner, Kansas 66030
www.RoyalInspectionsKC.com

DATE OF INSPECTION:	1/15/2016	123 New Home Street Your City, Kansas 66030
INSPECTED FOR:	Home Owner

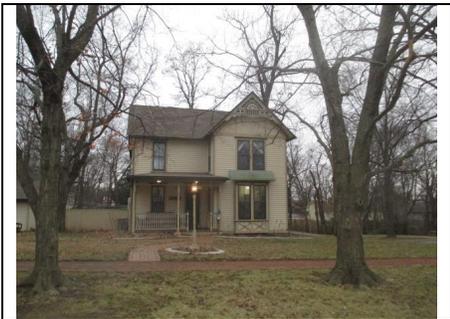
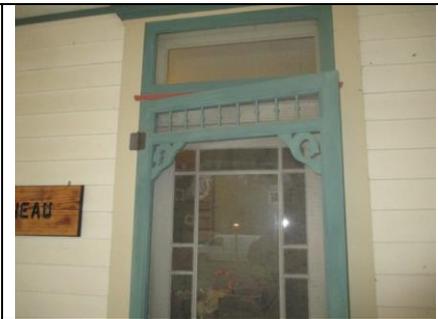
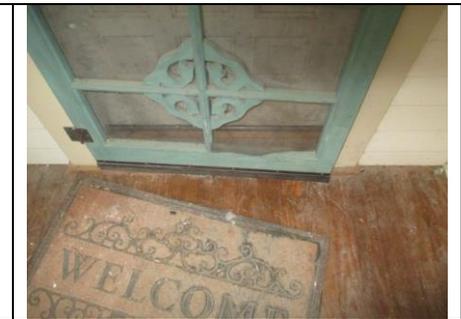
<p>Front storm Door does not close properly and needs adjustment.</p>	<p>Damaged screen on front storm door.</p>

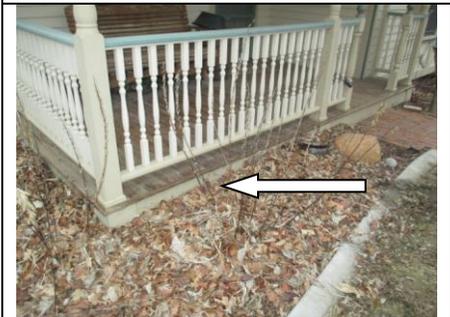
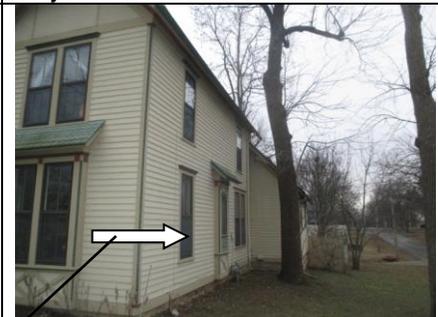
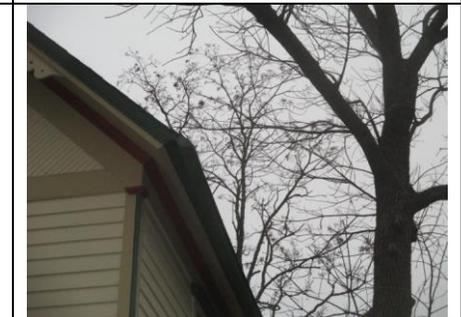
<p>Front porch floor needs maintenance/stain/sealer. Keep debris away from wood.</p>		<p>Gutter on NW end of home is not hanging properly, likely needs cleaning.</p>

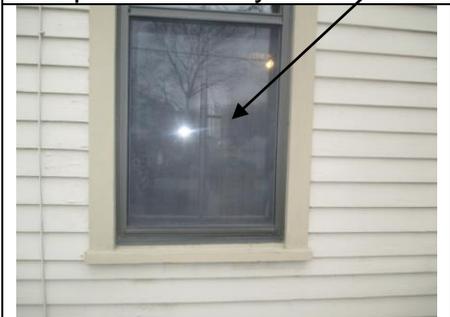
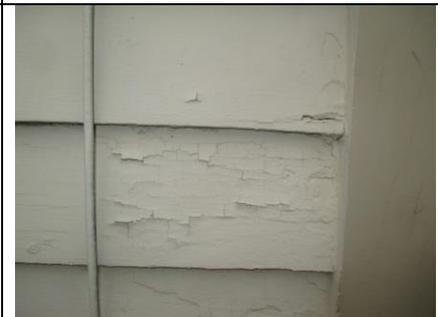
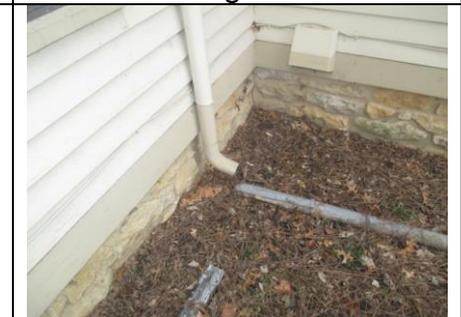
<p>Small hole in screen.</p>	<p>Several areas around the home need maintenance paint.</p>	<p>Downspout discharges near the home, disconnected from extension.</p>

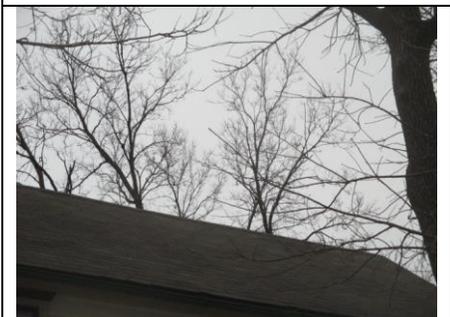
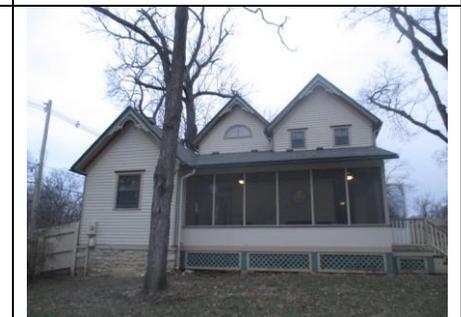
<p>Keep trees trimmed off roof.</p>	<p>Shed.</p>

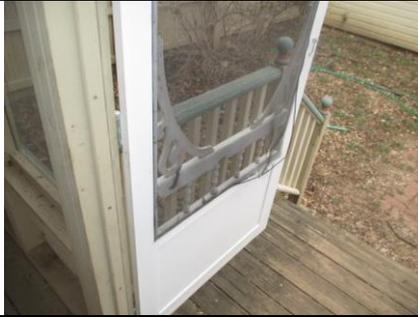
Damaged screen on back porch door.

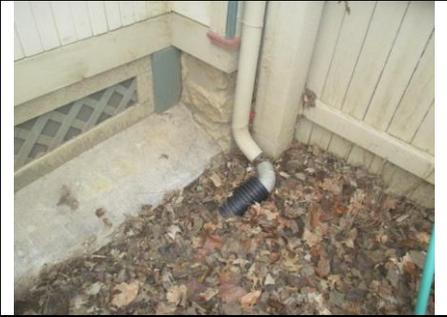
Downspout disconnected near back porch.

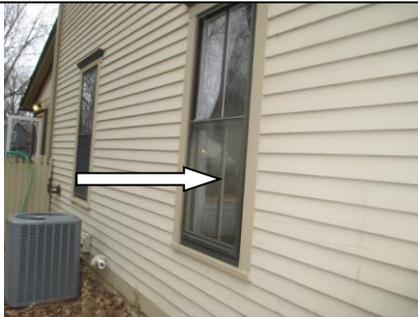
Missing screen, E end of home.

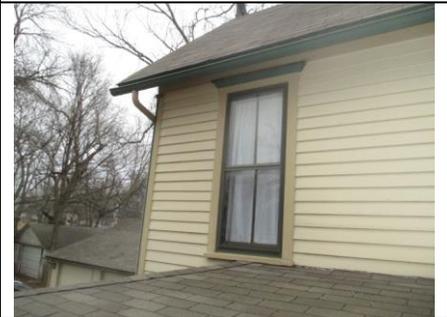
Missing screen, upper NE bedroom.

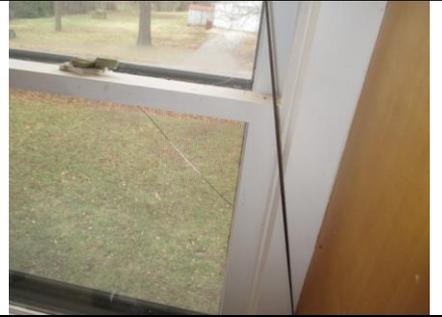
Cracked window pane above kitchen sink.

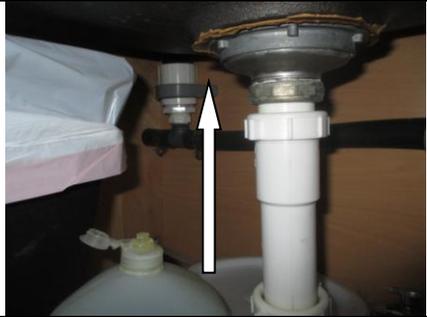
Recommend high loop on dishwasher drain.

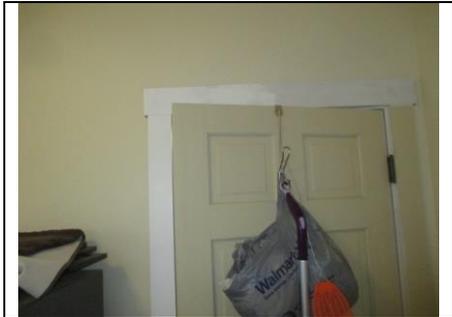
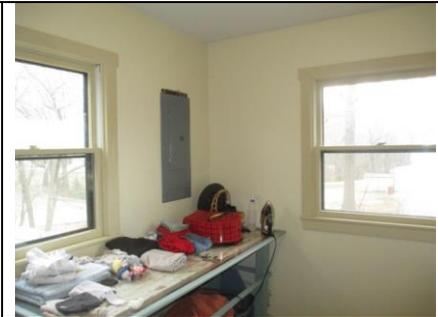
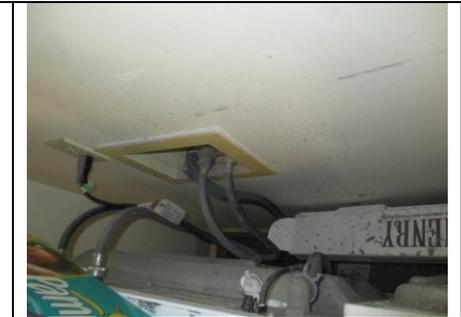
<p>Door does not close properly and needs adjustment.</p>		<p>Recommend braided stainless steel washer hoses.</p>

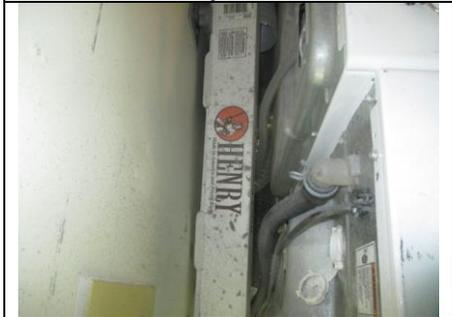
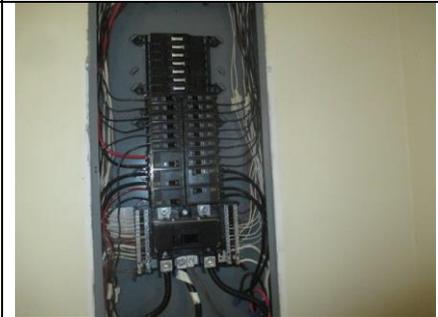
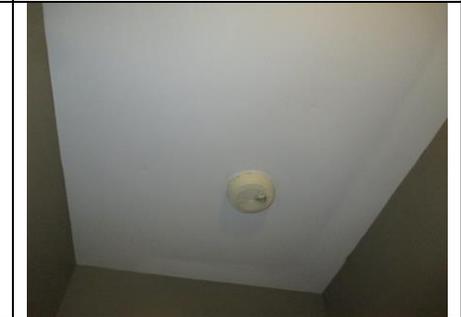
<p>Do not recommend use of foil or plastic dryer vents.</p>	<p>200 amp service.</p>	<p>All smoke alarms over 10 years old should be replaced, several missing, batteries removed, etc.</p>

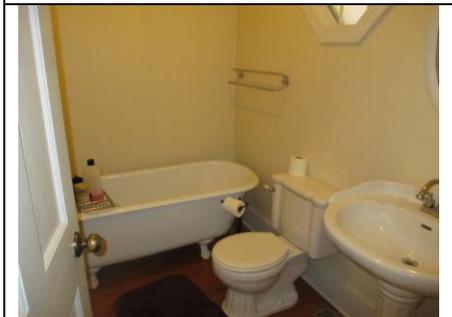
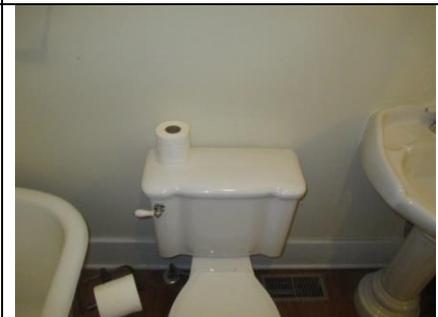
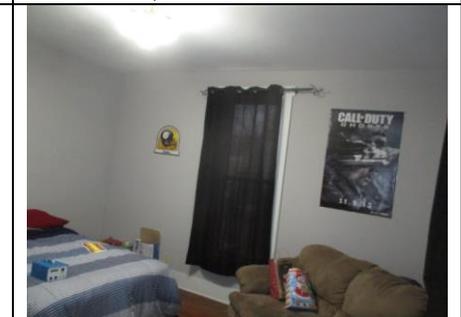
<p>Toilet tank wobbles, does not currently leak.</p>

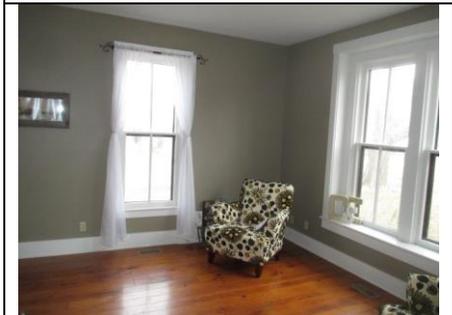
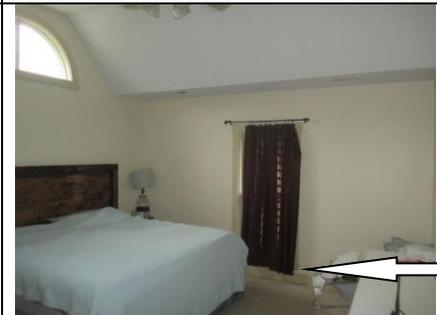
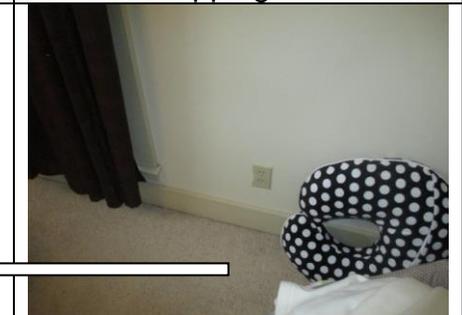
<p>Broken cover plate.</p>

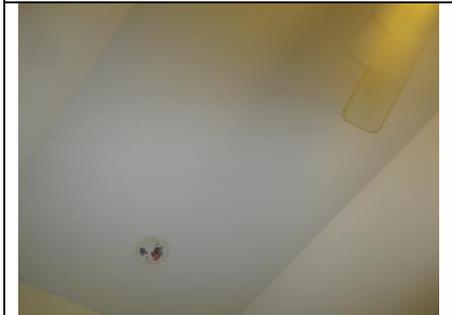
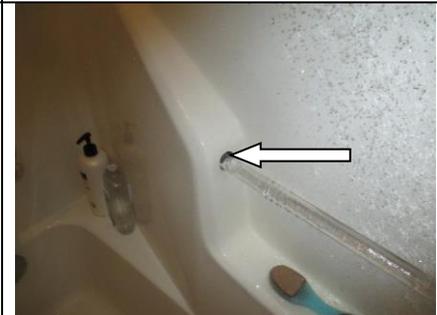
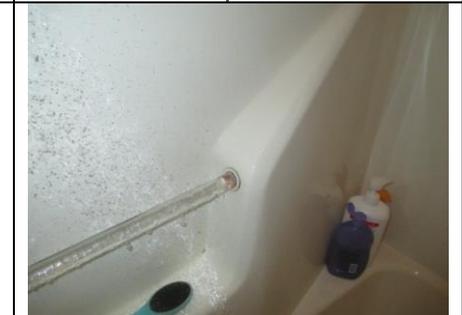
<p>Missing smoke alarm.</p>	<p>Missing washer to prevent water from entering shower insert handle.</p>	<p>Correct on right side.</p>

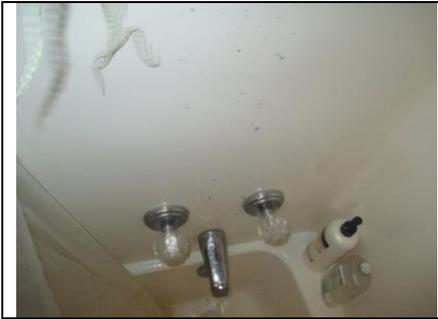
Recommend repair or replacement of caulk around bath fixtures. 8-4 o'clock.

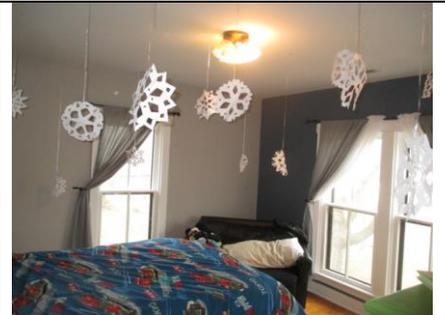
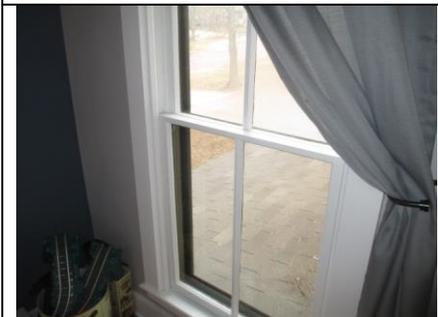
Two windows in upper NW bedroom stick.

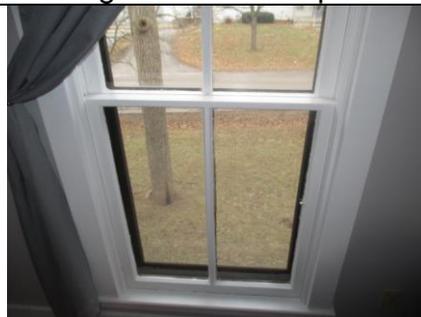
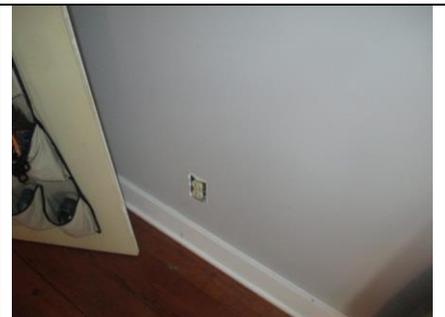
Missing/broken cover plates.

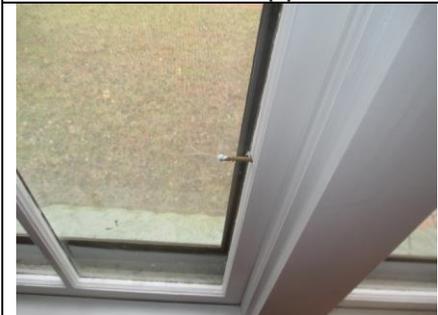
Pin does not enter lock, N window, upper NW bedroom.

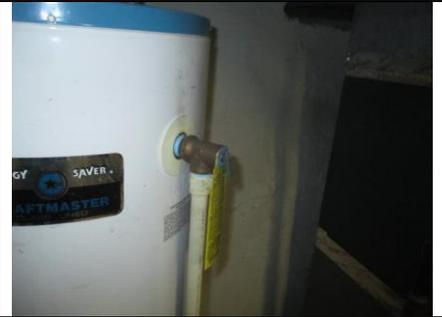
T-P valve on water heater does not operate properly, recommend replacement.

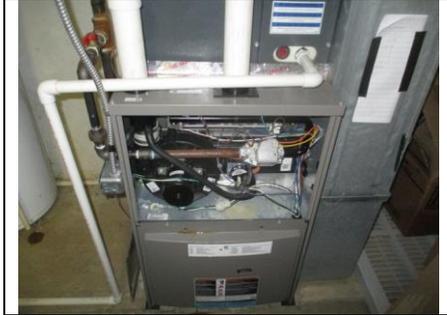
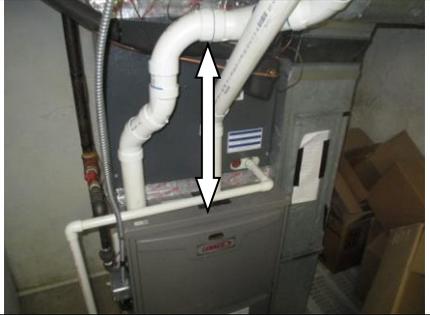
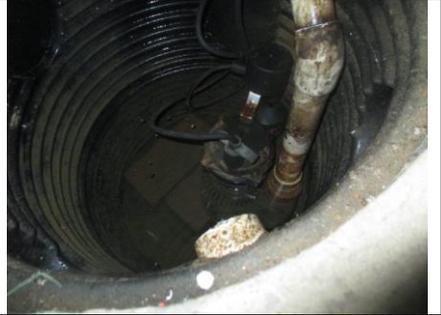
<p>Appears ok.</p>	<p>Leak in furnace flue, dripping condensate.</p>	<p>Sump pump appears ok. Replace at a minimum every 10 years.</p>

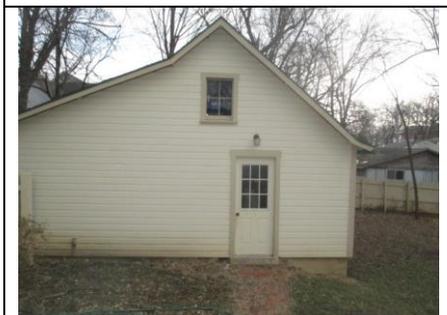
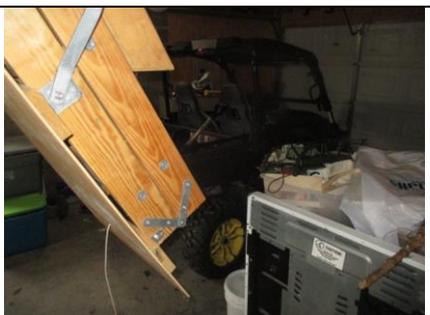
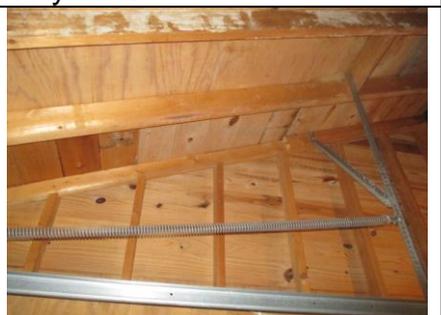
<p>No access above garage.</p>	<p>Safety cables are missing from garage door helper springs.</p>

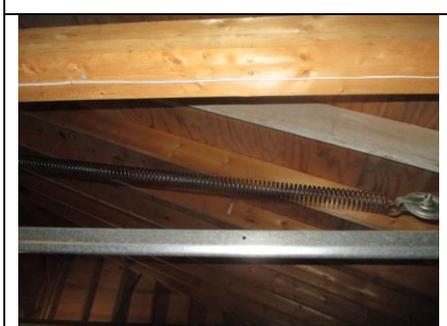
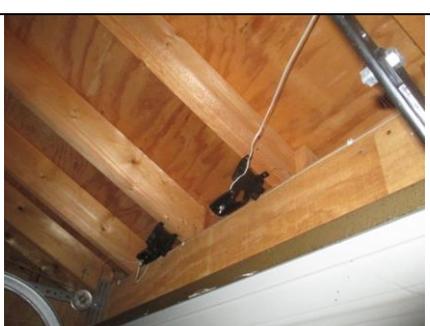
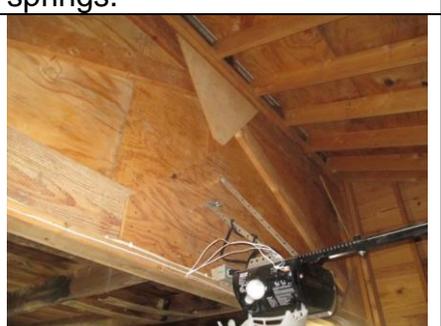
<p>Safety cables are missing from garage door helper springs, both doors.</p>	<p>Auto reverse photo cells should be installed approximately 6 inches from the floor.</p>	<p>Garage door opener did not operate, unique securing mount.</p>

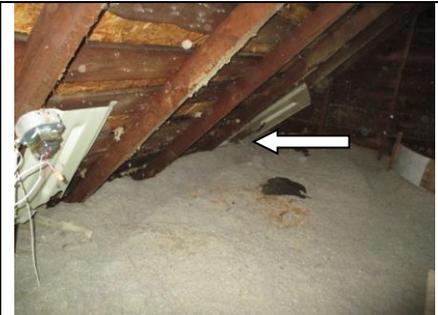
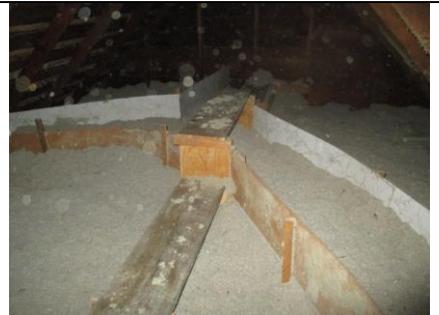
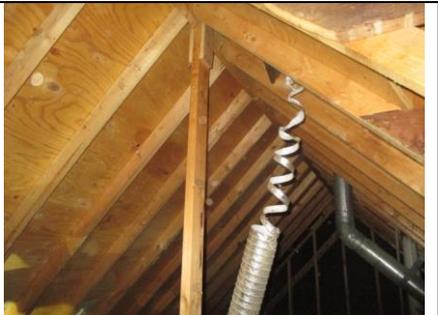
<p>Damage to soffit vent/insulation guard foam.</p>	<p>Insulation appears ok.</p>	<p>Bathroom vent separating.</p>

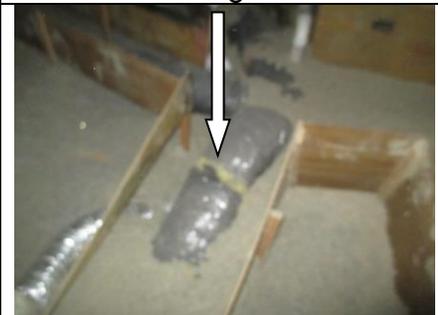
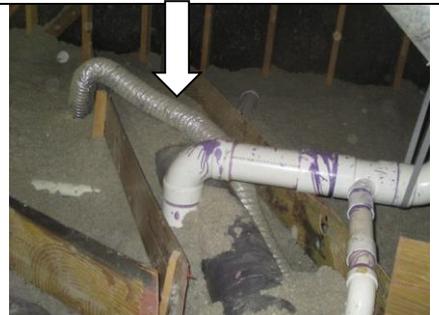
<p>Separation in duct work in attic.</p>	<p>Appears master bath vent discharges into insulation.</p>
