CHIMNEY AND FLUE MAINTENANCE

Chimney Flashing

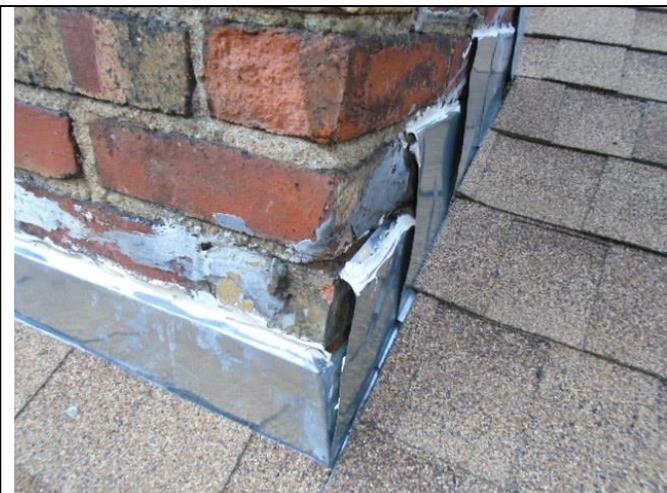
This photo shows a chimney with the proper flashing installed poorly. Note the counter flashing is not secure against the brick and the top is not sealed in the masonry joint.

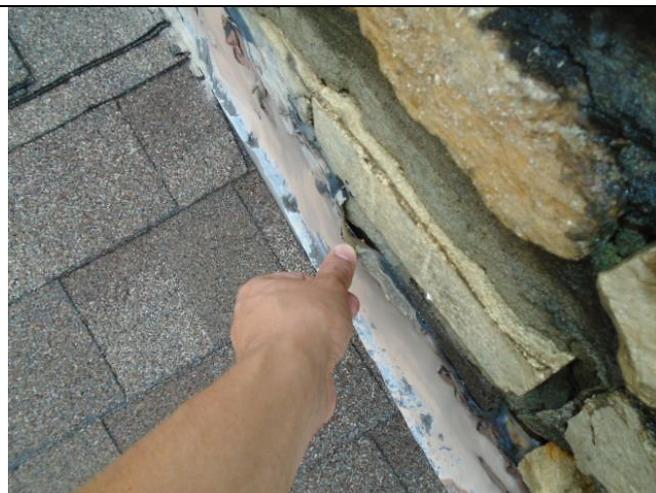
Close up of step flashing caulk that has deteriorated causing water penetration into the attic. This caused saturated insulation and interior wall and ceiling damage.

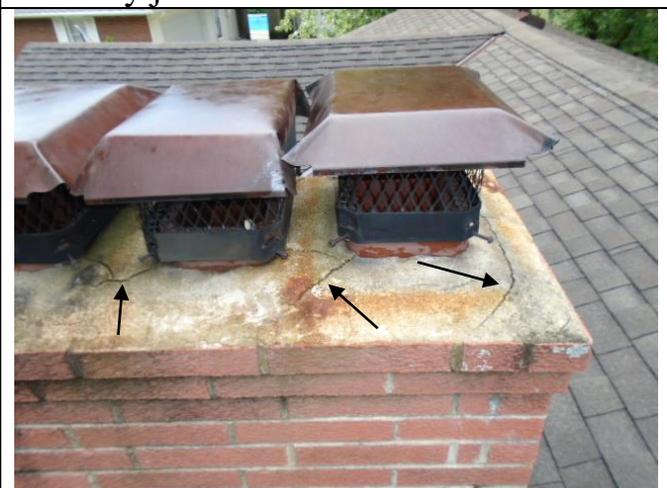
Cracks in chimney caps should be sealed brush on elastomeric sealant for long term protection. This covers the entire chimney cap and provides a waterproof seal.

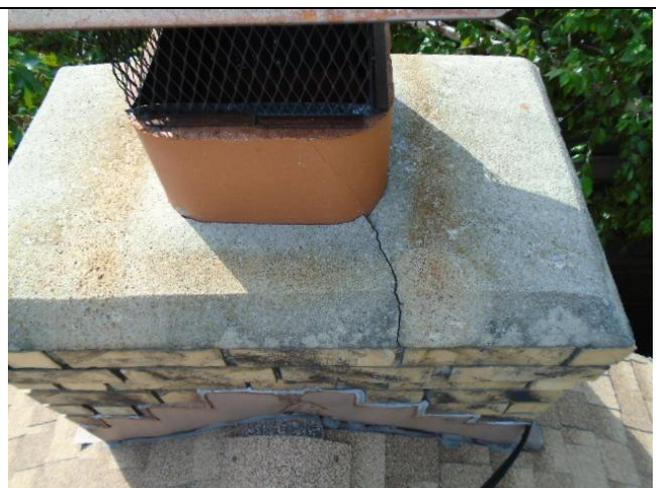
Some cracks are large enough that you can apply a polyurethane caulking to fill cracks prior to applying the brush on sealant.

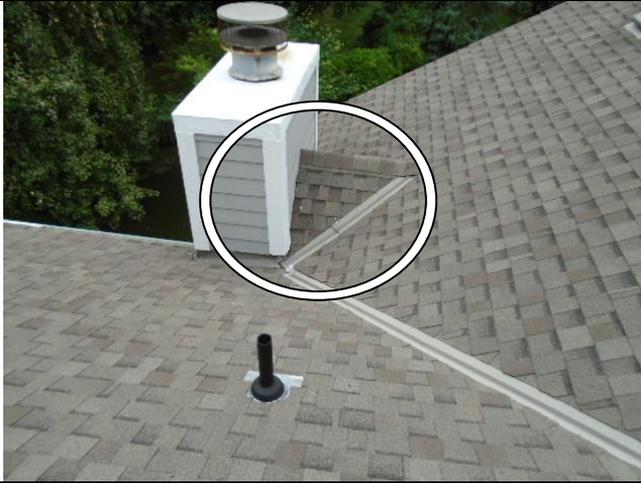
A chimney cricket is a 'peak' at the center of the chimney base that diverts water and minimizes the potential for snow accumulation. A cricket, as shown here, is recommended for any span over 30 inches.

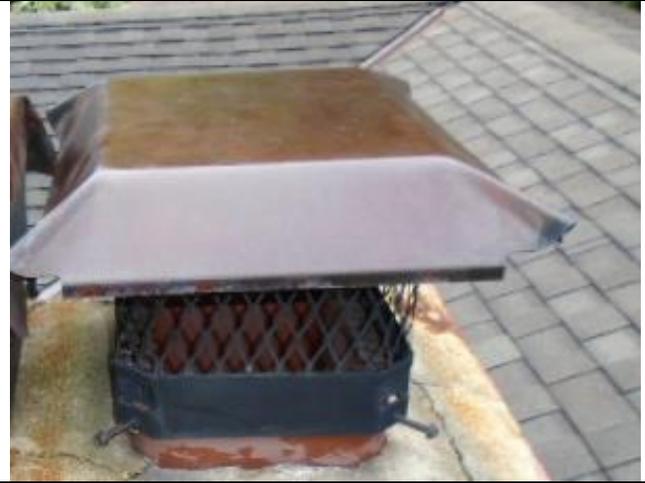
We recommend installing chimney covers to prevent pest and moisture intrusion.

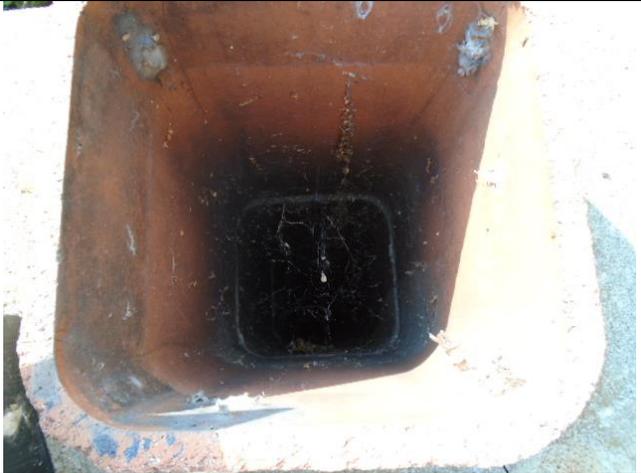
Interior view of unlined masonry chimney. We recommend liners for all chimney applications be installed by a licensed professional to ensure the appropriate flue liner material is used for each application.

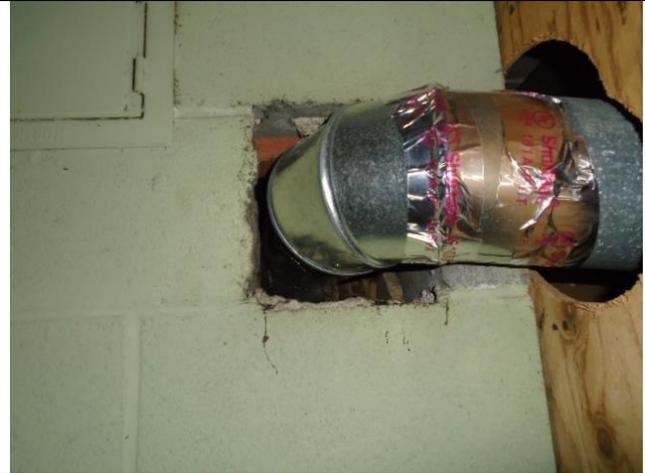
This photo shows a gas appliance flue discharging into an open masonry chimney; this has a high potential for flue gasses to leak back into the home due to pressure differential and down drafting.

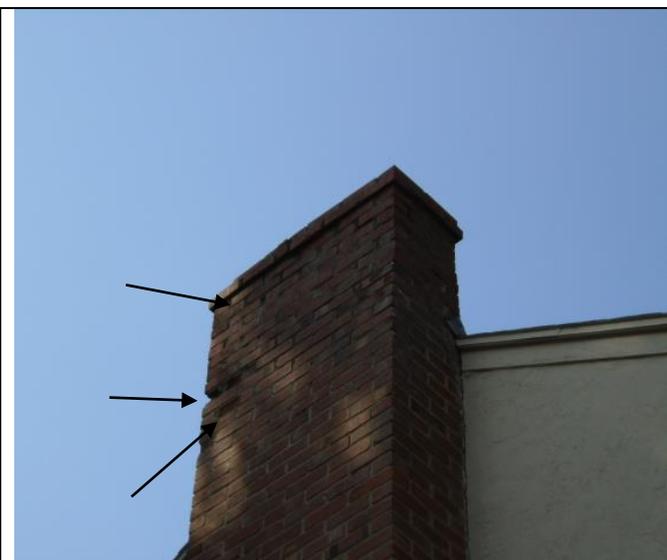
Spalling occurs when brick deteriorate and layers 'flake off' causing damage.

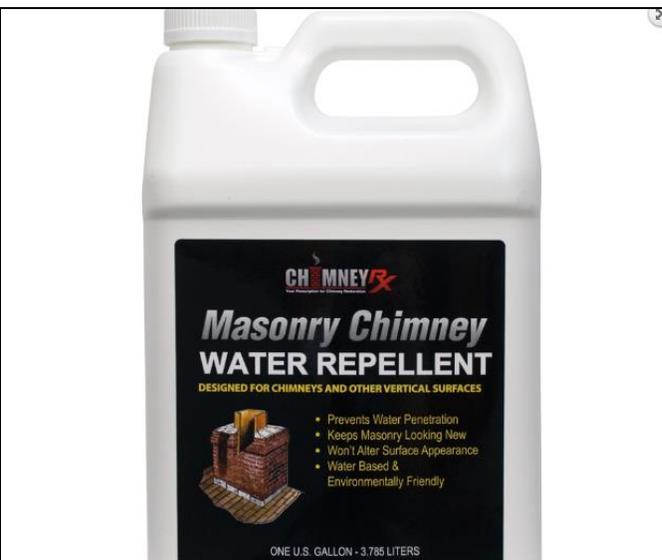
Prevent spalling by spraying on a penetrating masonry/brick sealer. There are several products to choose from.

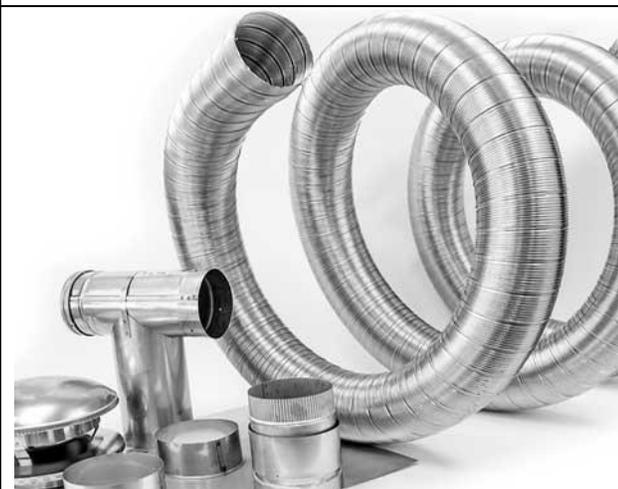
A chimney liner should always be installed up the full height of a clay/terracotta flue. Some are installed in sections and others are continuous flexible flue liners.

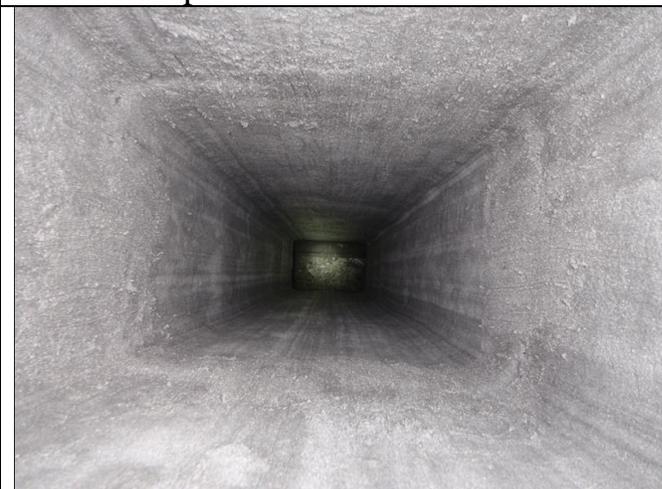
Photo of a relined chimney completed instead of installing a steel liner. This type of repair is completed using a sprayer.
