Michael Dandurand, P.E.
637 East Willow Street
Gardner, Kansas 66030
www.RoyalInspectionsKC.com

ICE DAMS

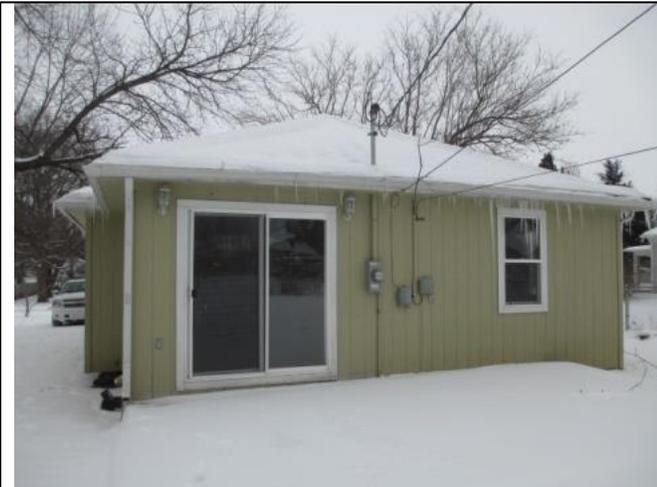
Recent snow fall over a few days caused build up on the roof.

The photos below show a home with no insulation in the attic. Heat from the interior of the home passed through the attic space and warmed up the roof. This caused the snow to melt from the bottom up. The outside temperature was in the mid 20°'s Fahrenheit. The water from snow melting slowly drained down the roof until it reached the edge of the roof and gutter system. Because the gutter system is not receiving heat from the attic space the water froze and created an ice dam.

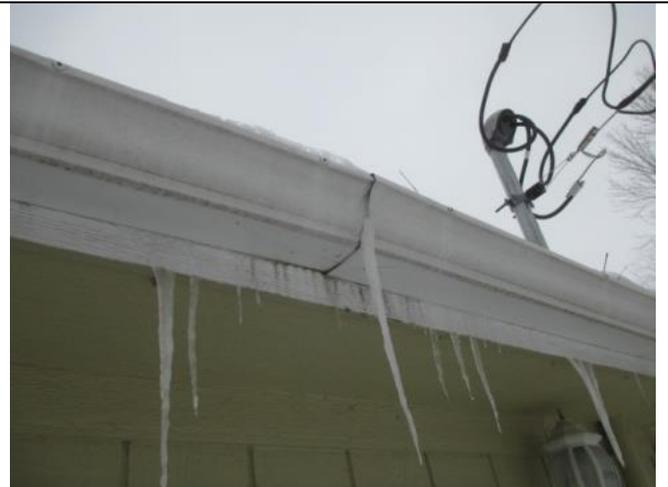
Ice dams formed in the gutters and backed up on the perimeter of the roof.

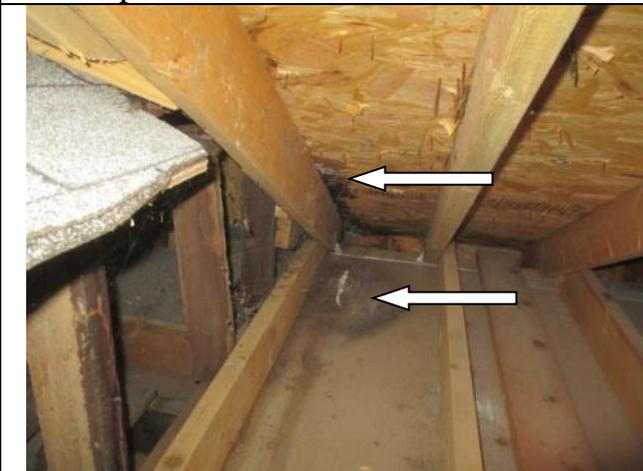
Water damage and mold/mildew growth on the interior drywall and wood framing and roof decking can be clearly seen here.

In this particular instance the water leaking into the home caused wood rot on the roof decking and mold growth in the attic space.

As you can see there is no insulation in the attic space of this home. The water began to leak into the attic space and caused water stains that were visible from the living areas below, mold and mildew growth, and wood rot on the decking.

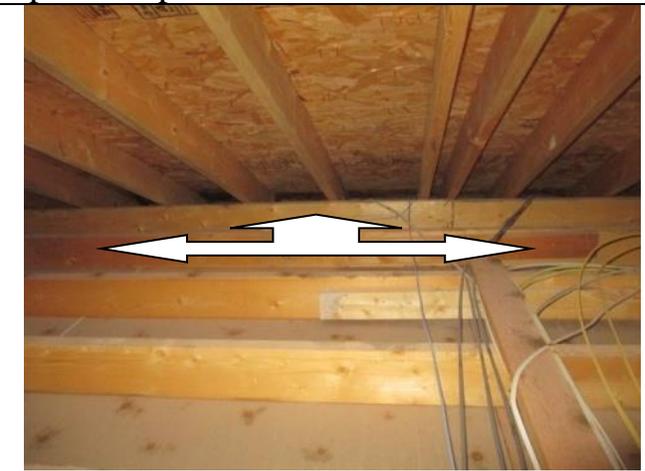
The dark staining on the lower section of roof decking is where water had begun to cause wood rot.
