Michael Dandurand, P.E.
637 East Willow Street
Gardner, Kansas 66030
www.RoyalInspectionsKC.com

KICKOUT

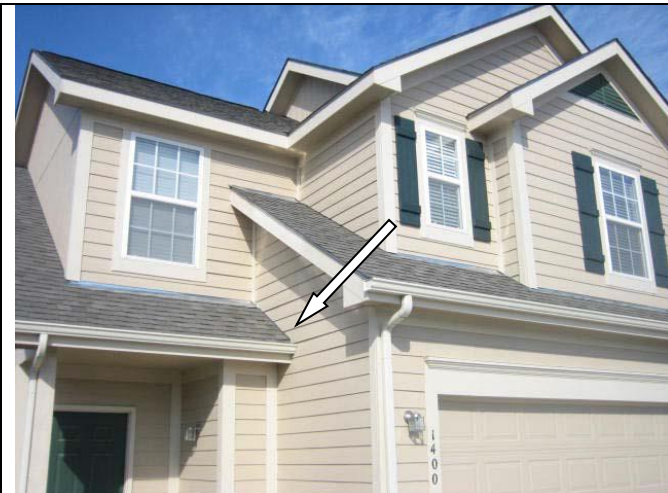
Typical location where a kickout is installed.

Water leaking between a gutter and the siding on a sidewall of a home can cause significant damage if not corrected. The problem can occur where a sidewall meets up with a roof and gutter in which one section of the home has a higher roofline. This is common on two story homes adjacent to garages, around chimneys, over front porches and a number of other locations. Water can leak between the gutter and siding. This can cause damage to the siding. In extreme scenarios it can damage interior walls, moisture and mold buildup on insulation, and even damage flooring if not corrected.

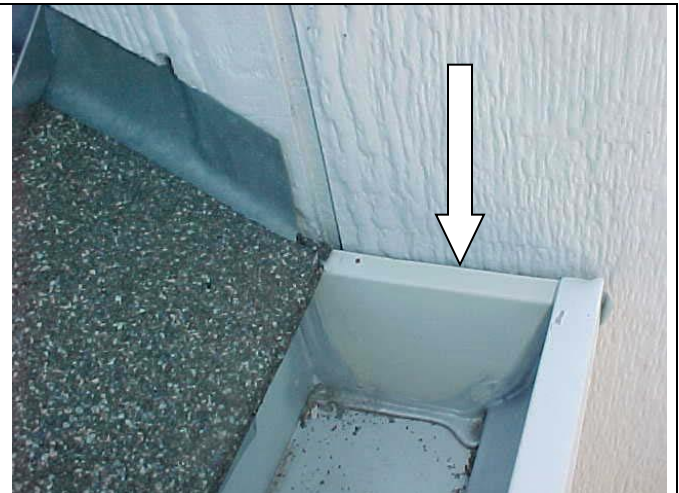
Close-up view showing where water can seep between the gutter and siding.

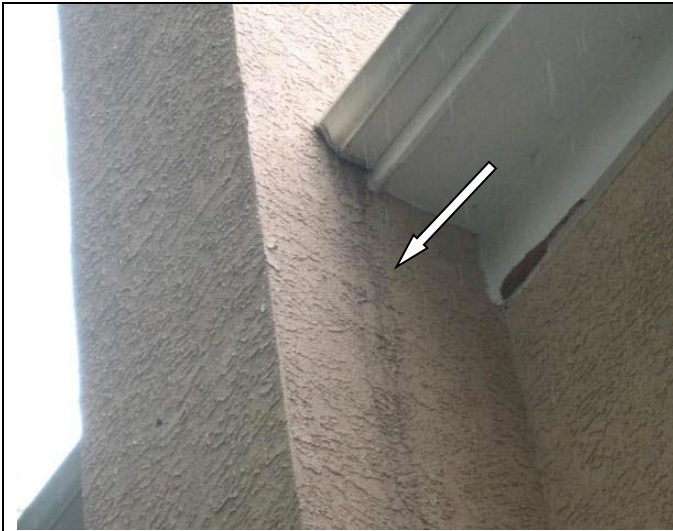
Water staining, prior to any significant damage.

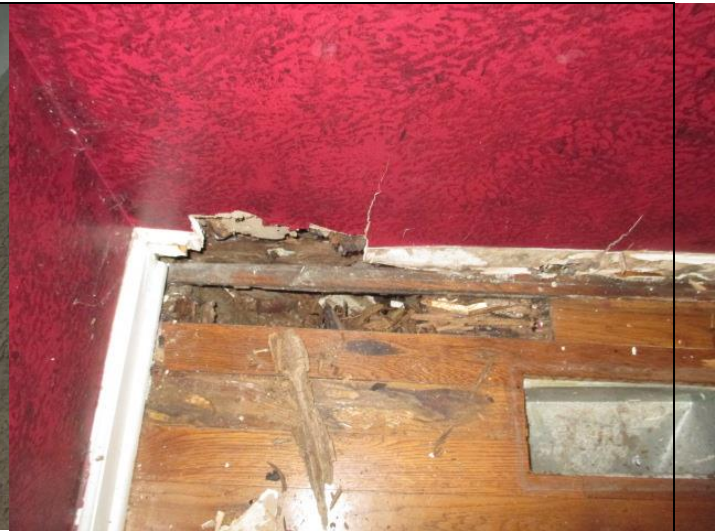
Damage to the interior flooring. The wall behind also showed significant damage.

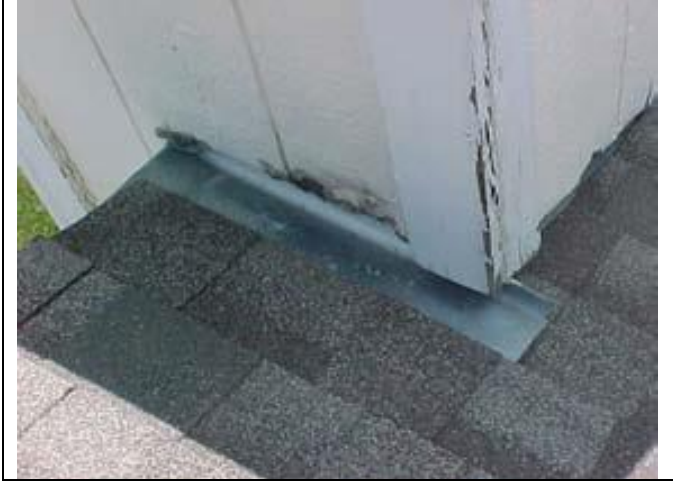
Damage to a chimney with flashing installed.

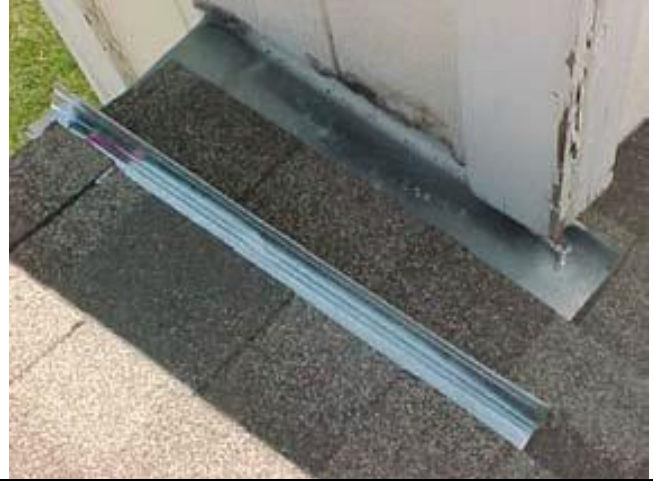
Chimney kickout installed.

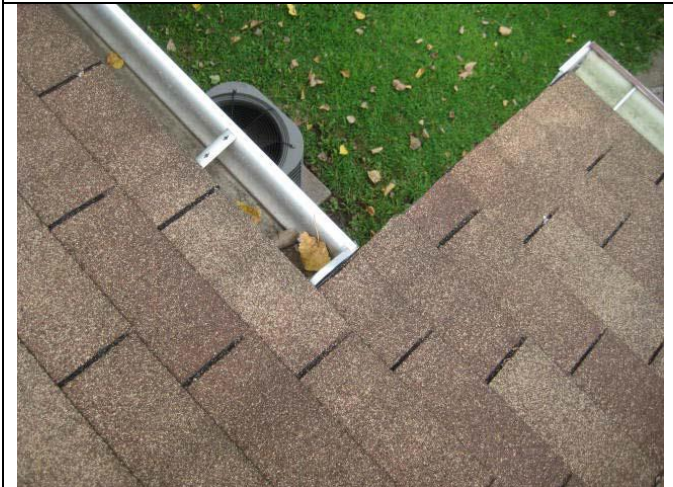
Overlapping roof location.

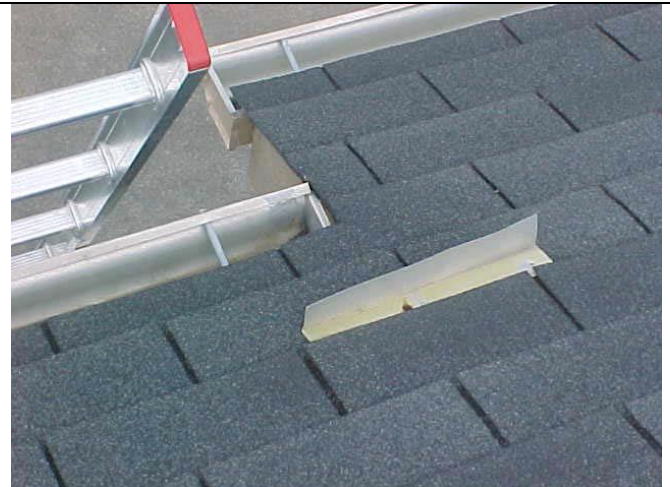
Overlap kickout installed.

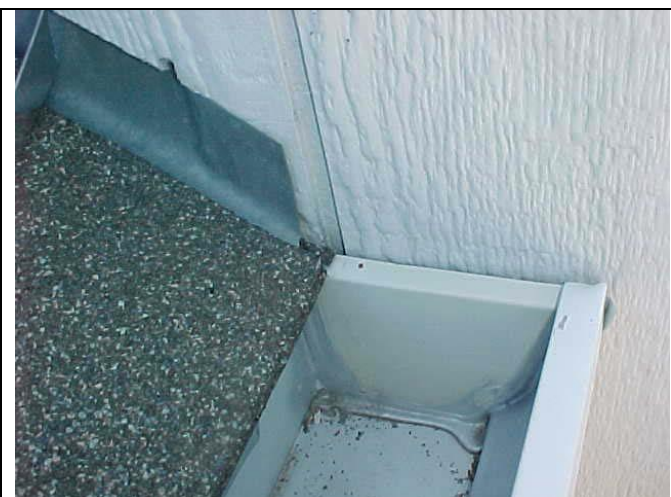
Typical kickout location with a higher roof line.

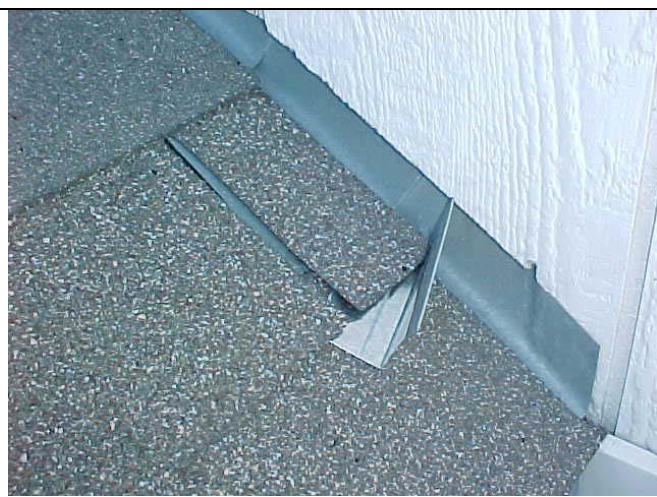
Higher roof line kickout installed.

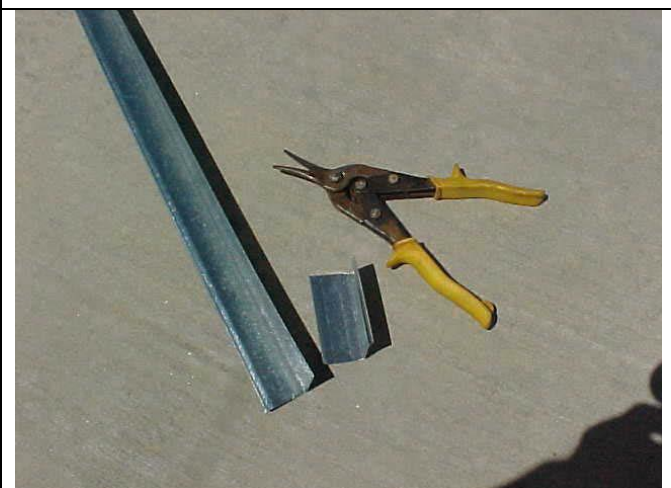
Tin snips used to cut "L" flashing.

The simplest way to divert the water away from the siding, chimney or other location is to cut a piece of “L” shaped drip edge with tin snips. We recommend a minimum of 4 inches, however longer sections are easier to install as they allow for more surface area under the shingle. You can cut the kickout in a variety of shapes to fit your specific configuration. Below are a few photos of drip edge being cut and installed. The drip edge costs approximately \$3.00 for 10 feet. It cuts easily with tin snips and can be slid under the first shingle tab. After the first hot day, the tar under the shingle should self-seal to the drip edge; if it does not and the drip edge comes loose you can use roofing tar to secure it in place.

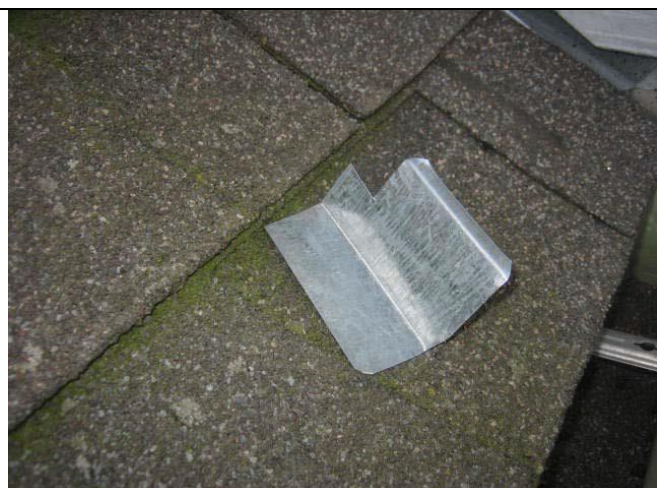
Notch cut in flashing to fit under overlapping siding.
