Michael Dandurand, P.E.
637 East Willow Street
Gardner, Kansas 66030
www.RoyalInspectionsKC.com

ROOF BOOT REPAIR

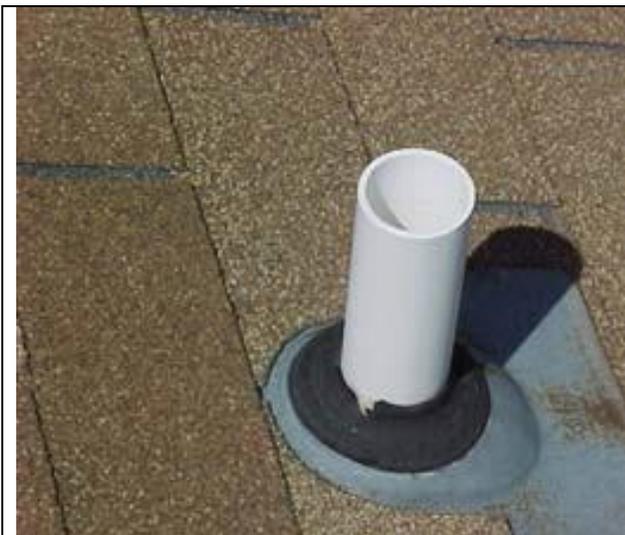
This photo shows a typical sewer gas vent pipe with a deteriorating boot.

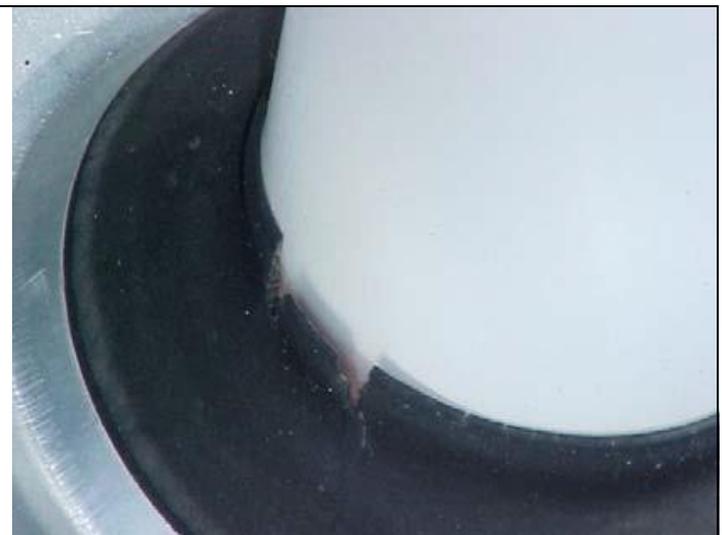
Close up view of a damaged roof boot.

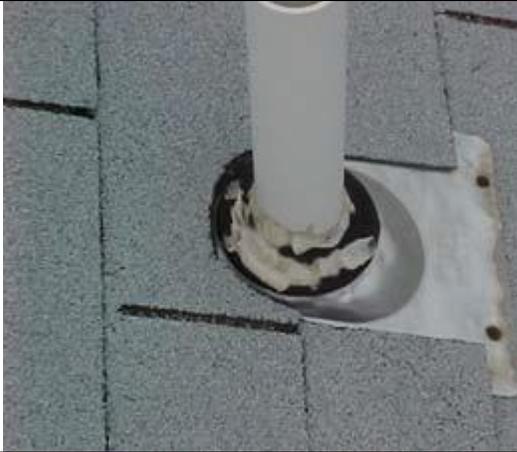
This shows a caulked roof boot that was damaged, caulking will deteriorate and will not likely prevent water intrusion.

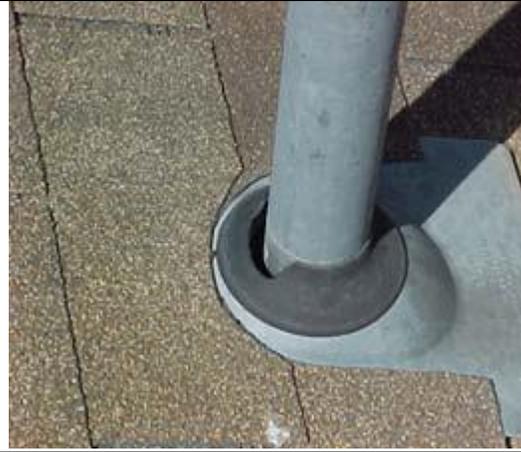
This photo shows a typical service entrance conduit with a damaged boot.

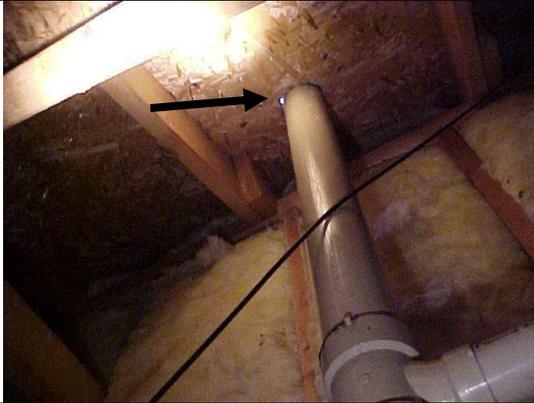
View looking up towards a roof boot inside the attic, daylight is visible.

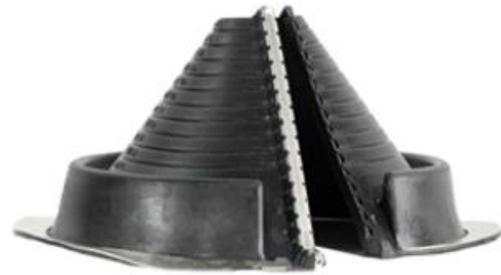
This shows a retrofit roof boot for use around service entrance masts where a typical boot cannot be slid over the top of the mast.

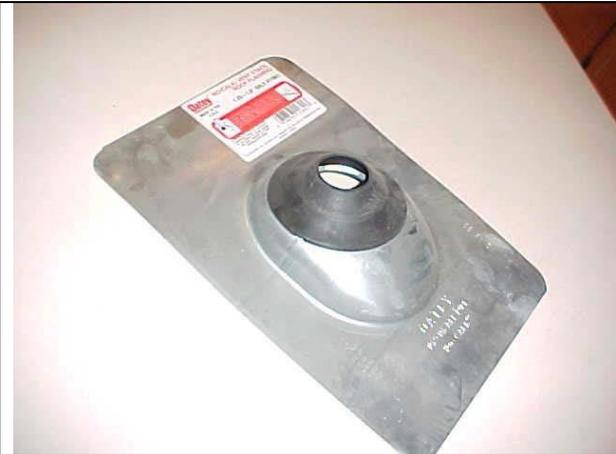
Purchase the entire roof jack flashing from your local hardware store.

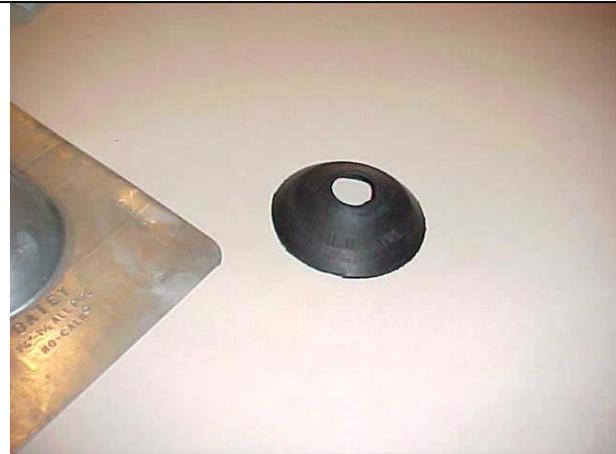
Carefully cut the rubber section out of the middle with a box knife or similar tool.

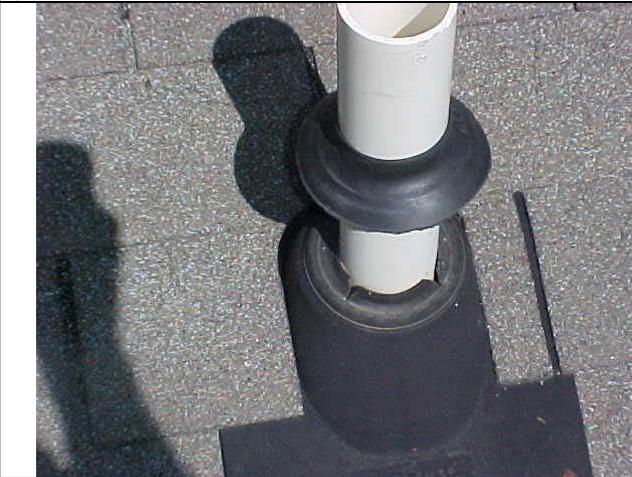
Make sure that you cut out the correct center hole of the boot for a good seal.

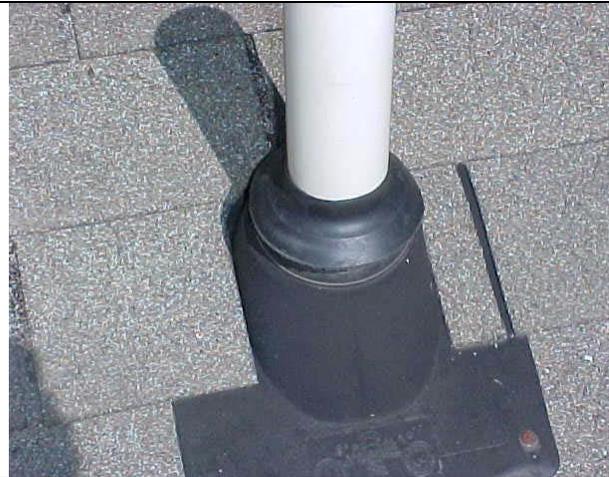
Slide the boot down the pipe until it is firmly atop the existing flashing.
