Michael Dandurand, P.E.
637 East Willow Street
Gardner, Kansas 66030
www.RoyalInspectionsKC.com

DOOR PLATE INSTALLATION

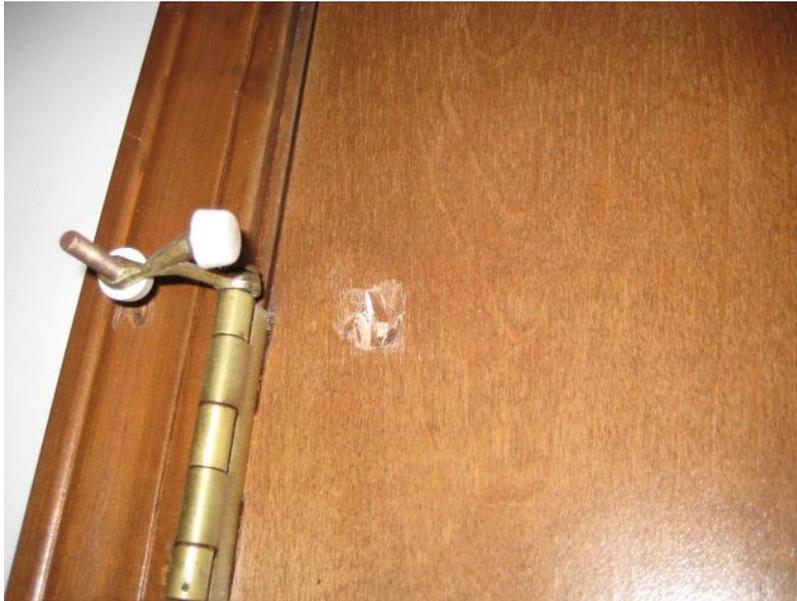
It is not uncommon to find a hole in the door near the top hinge on hollow core doors. Sometimes the door stop is installed properly, (with the fixed arm towards the door) and sometimes they are installed backwards (with the adjustable arm towards the door). In the photo above you can see that, even with a properly installed door stop, damage can occur to the door and even the trim. The instructions below will show how to repair the hole in the door using cabinet pull backer plates and adhesive. This repair can be completed before a hole occurs and it will spread the load over a larger area of the door and minimize the potential for future damage.

The cost for a cabinet pull backer plate, adhesive and a few minutes of your time is significantly less than the cost for a new door and a service charge for installation. You can purchase a cabinet backer plate for approximately \$2.00 compared to the cost of a new door which can cost from \$200.00 to \$400.00 depending on style and installation.

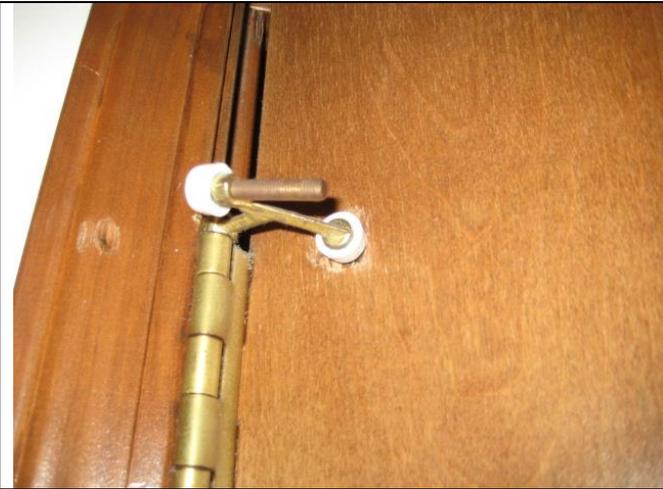
Make sure the door stopper is installed properly. If it is backwards, ensure that proper installation will still have the same impact location (hole) on the door.

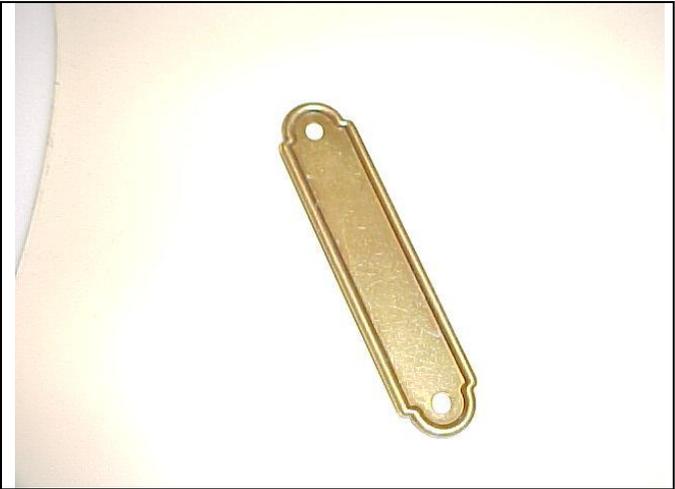
A cabinet pull backer plate is available at most hardware stores and come in a variety of styles and colors.

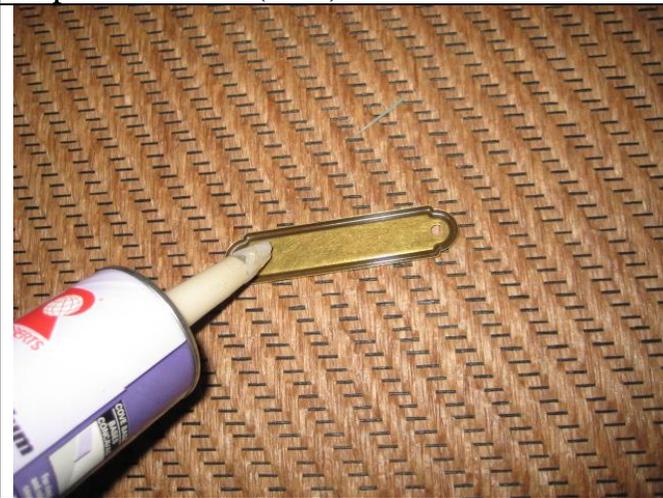
Apply a small amount of liquid nails or other adhesive to the back side of the backer plate. Do not apply so much that it squeezes out the side after pressure is applied to the door.

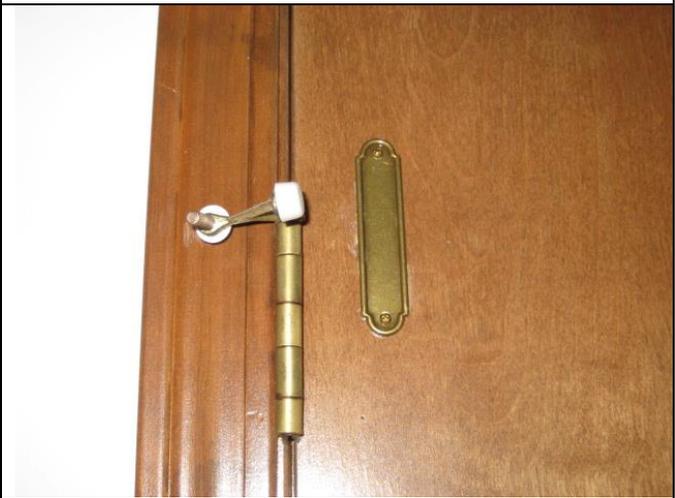
Install the two screws (top and bottom) in the backer plate. The finished repair looks like it was originally designed to be in place.
