Michael Dandurand, P.E.
637 East Willow Street
Gardner, Kansas 66030
www.RoyalInspectionsKC.com

DATE OF INSPECTION:	1/15/2016	123 New Home Street Your City, Kansas 66030
INSPECTED FOR:	Home Owner

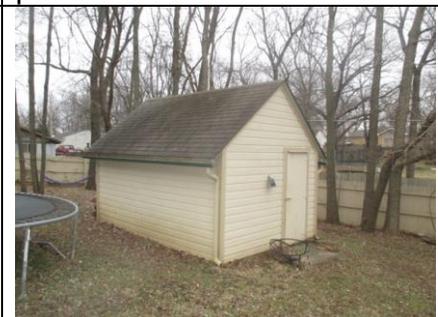
<p>Keep trees trimmed off roof.</p>	<p>Shed.</p>

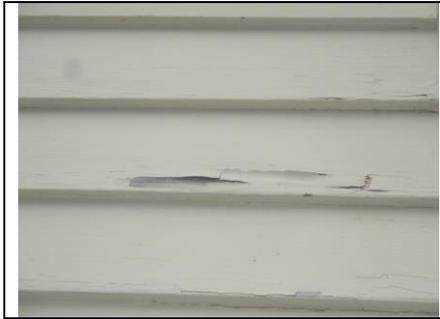
Maintenance paint.

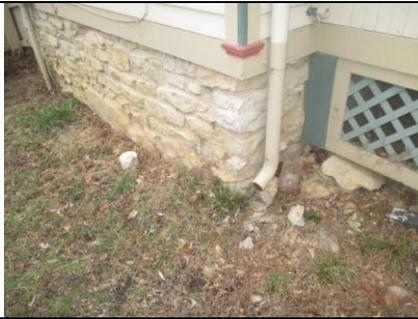
Downspout discharges near the home.

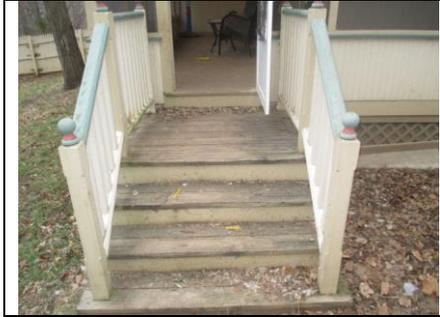
Back steps need maintenance.

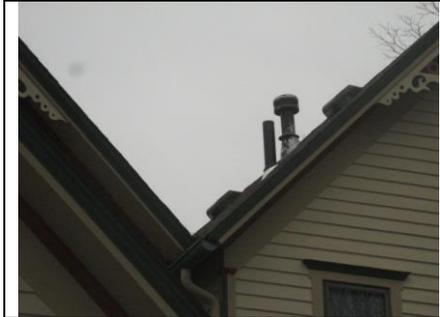
Keep roof valleys clear of leaves and other debris.

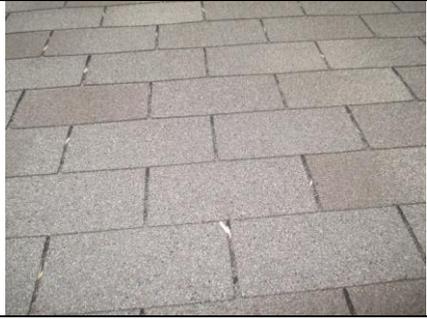
Roof appears ok.

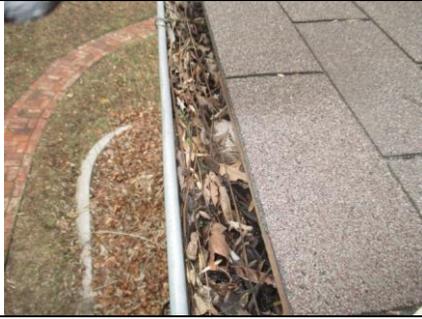
Gutters need cleaning.

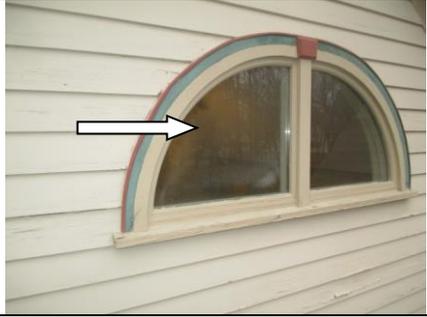
Compromised window seal in master bedroom.

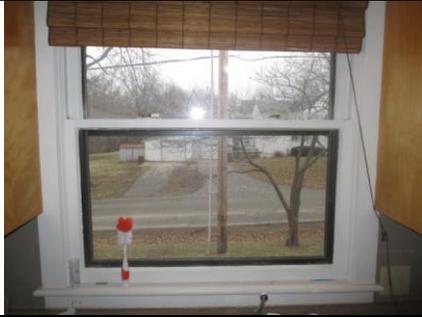
Several windows stick.

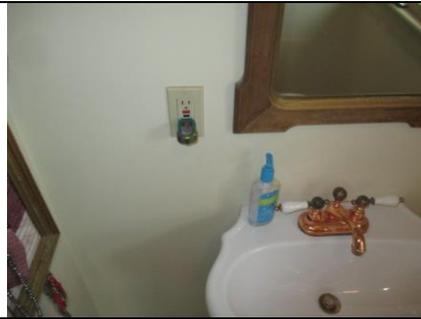
GFCI in master is connected to upstairs hall bath, reset hall then master if tripped.

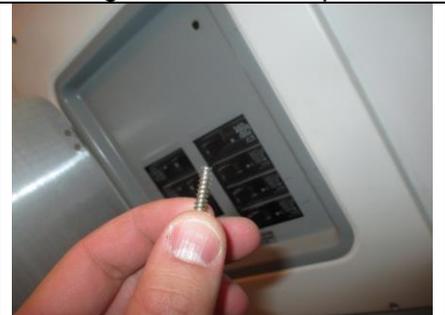
Blunt tipped screw.

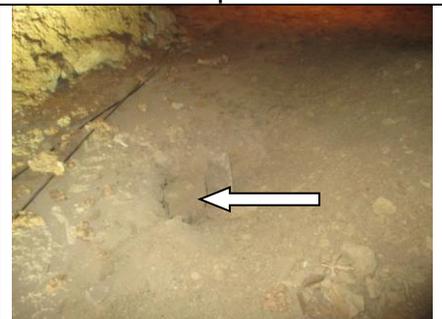
Animal burrow.

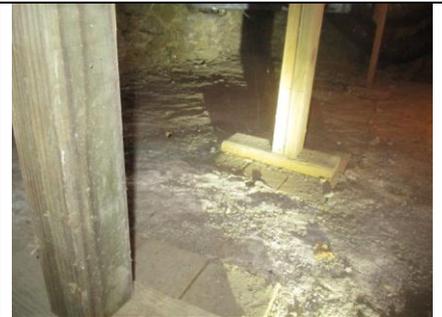
Wood posts on wood base, dry, appears ok.
